S-244
Jeptha Hayman Farm
Kingston vicinity
Private

historic name Hayman, Jephtha, House

The Jeptha Hayman House is a two-story, five-bay weatherboard frame dwelling that stands on the east side of the Westover-Marion Road on a slight rise of ground southeast of Kingston, Somerset County, Maryland. The oldest portion of the two-story, five bay frame dwelling is dated by an inscribed brick to 1836. Supported on a low in-filled brick pier foundation, the center hall main block was built in two stages, beginning in 1836 with a two-story side hall/parlor dwelling. The northern two bays of the main block were added within the following few decades, c.1850, thereby providing for a dining room and at the same time making the house more convenient by joining the service wing. The kitchen is estimated to date to the 1830s as well. Attached to the back of the house is a two-story one-room plan addition, the first floor of which is reported to have been moved from a site along the road. A turn of the twentieth century Tuscan columned porch supported on a rusticated concrete block knee wall stretches across the front of the house. The interior finishes of the main block remain largely intact

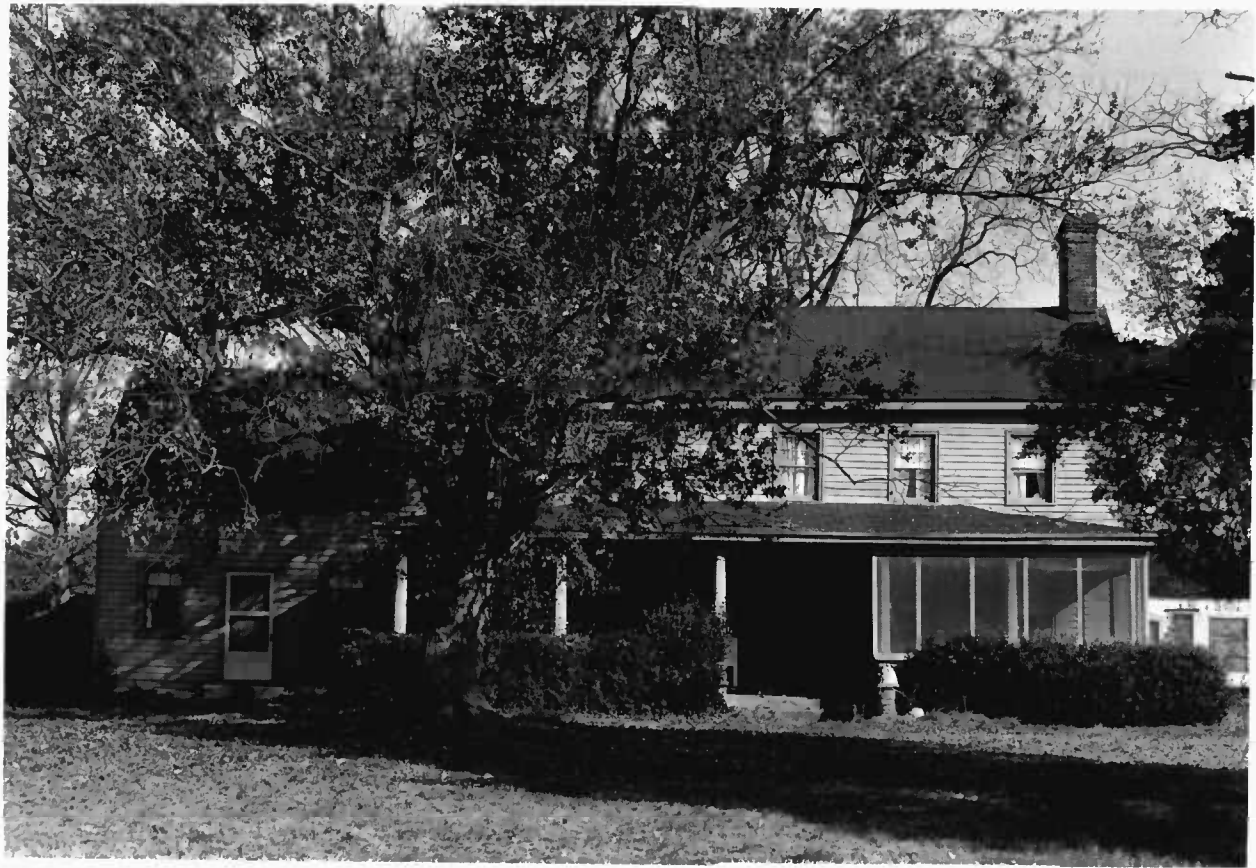
Jeptha Hayman Farm

West Elevation

The west (main) elevation is an asymmetrical five-bay facade with a center entrance and two uneven bays to each side. A raised six-panel door, framed by a stepped molding, is topped by a four-light transom. Nine-over-one sash windows light the first floor, and six-over-one sash windows illuminate the second floor. The window trim that frames the southern bays follows the stepped backband while the northern bays are framed by plain surrounds. A tuscan columned hip roof porch, supported by a rusticated concrete block knee wall, shelters the first floor.

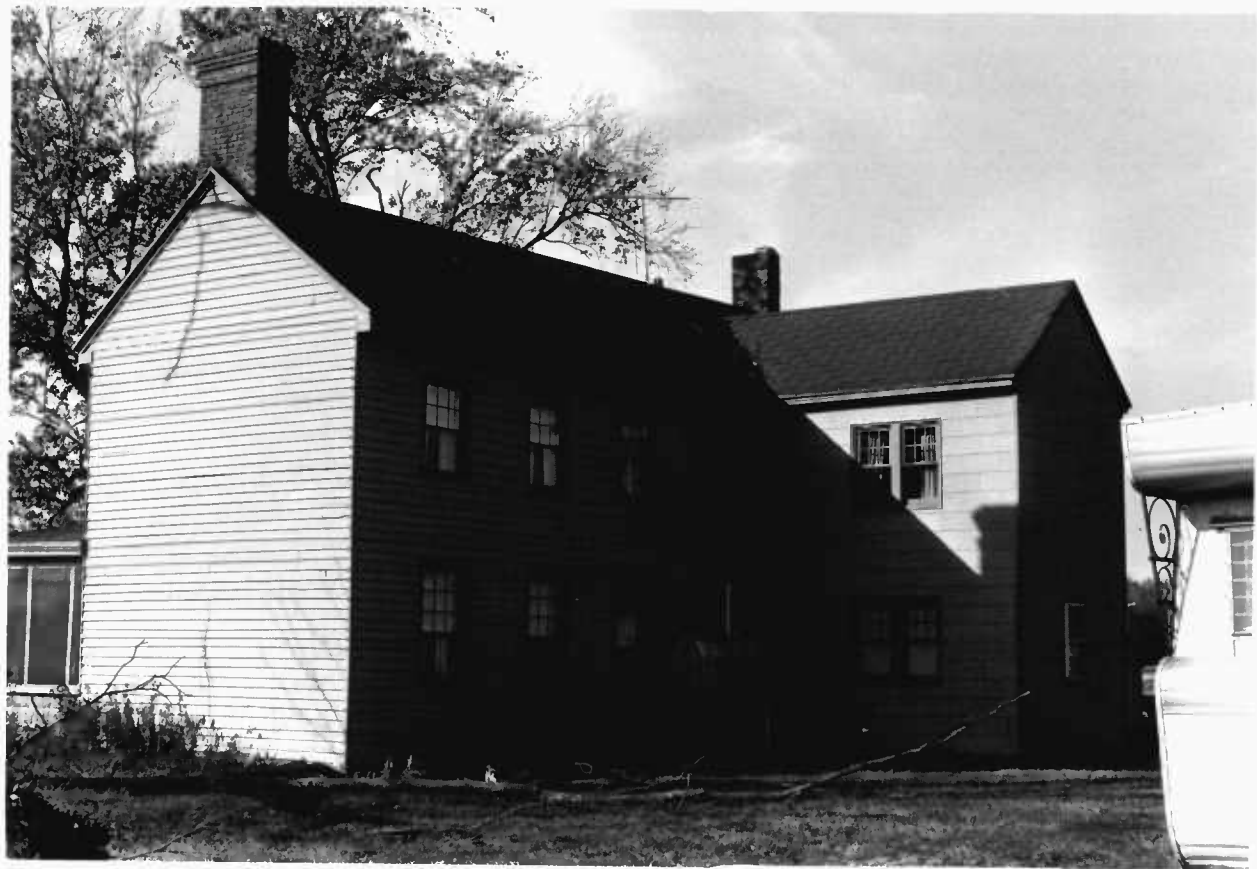
Jeptha Hayman Farm S-244
Near Kingston, Somerset County
Southeast Elevation
10/84, Paul Touart, Photographer
Neg/Md. Historical Trust

The south gable end is a plain weatherboard wall without window openings. A molded bargeboard finishes the flush gable end. Protruding through the roof is an interior end brick chimney finished with a corbelled cap. The date is inscribed in the east face of the stack.

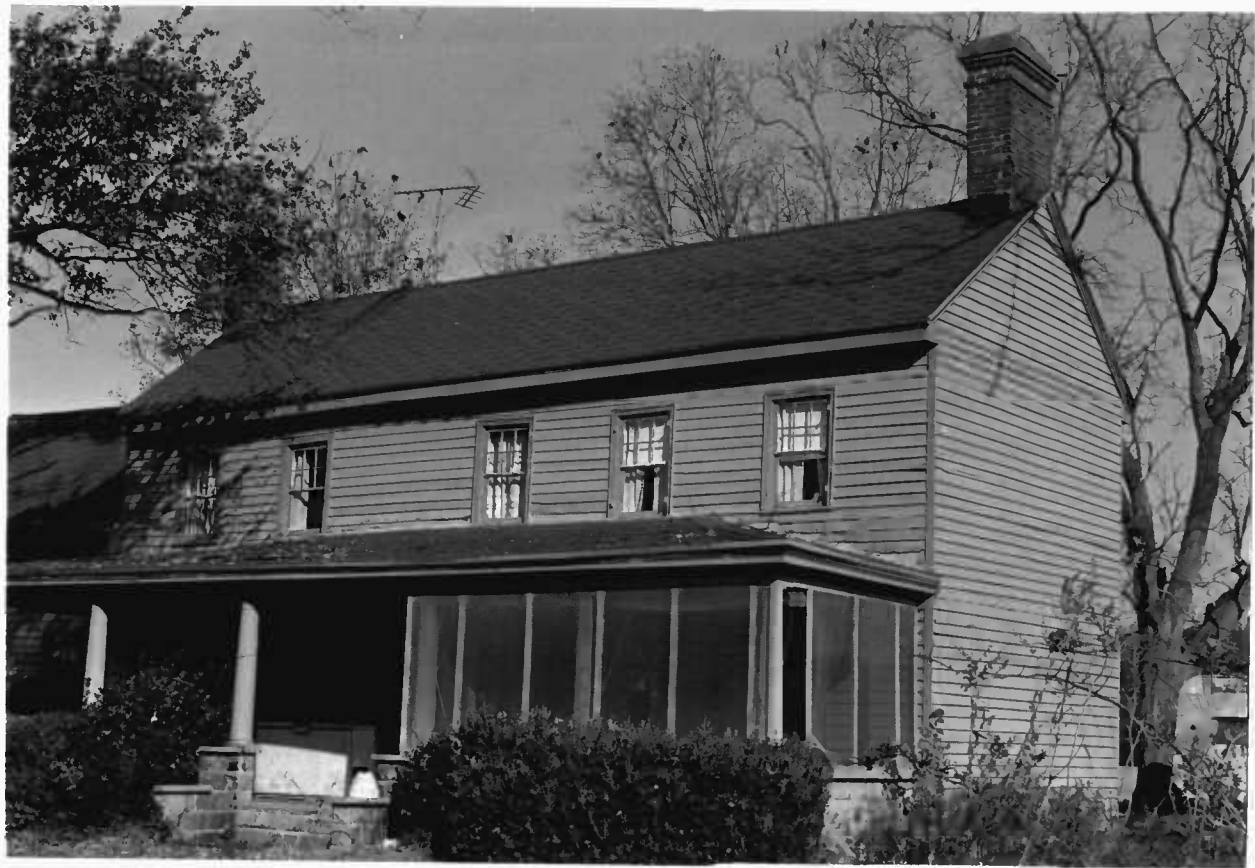
Jeptha Hayman Farm

Southwest Elevation

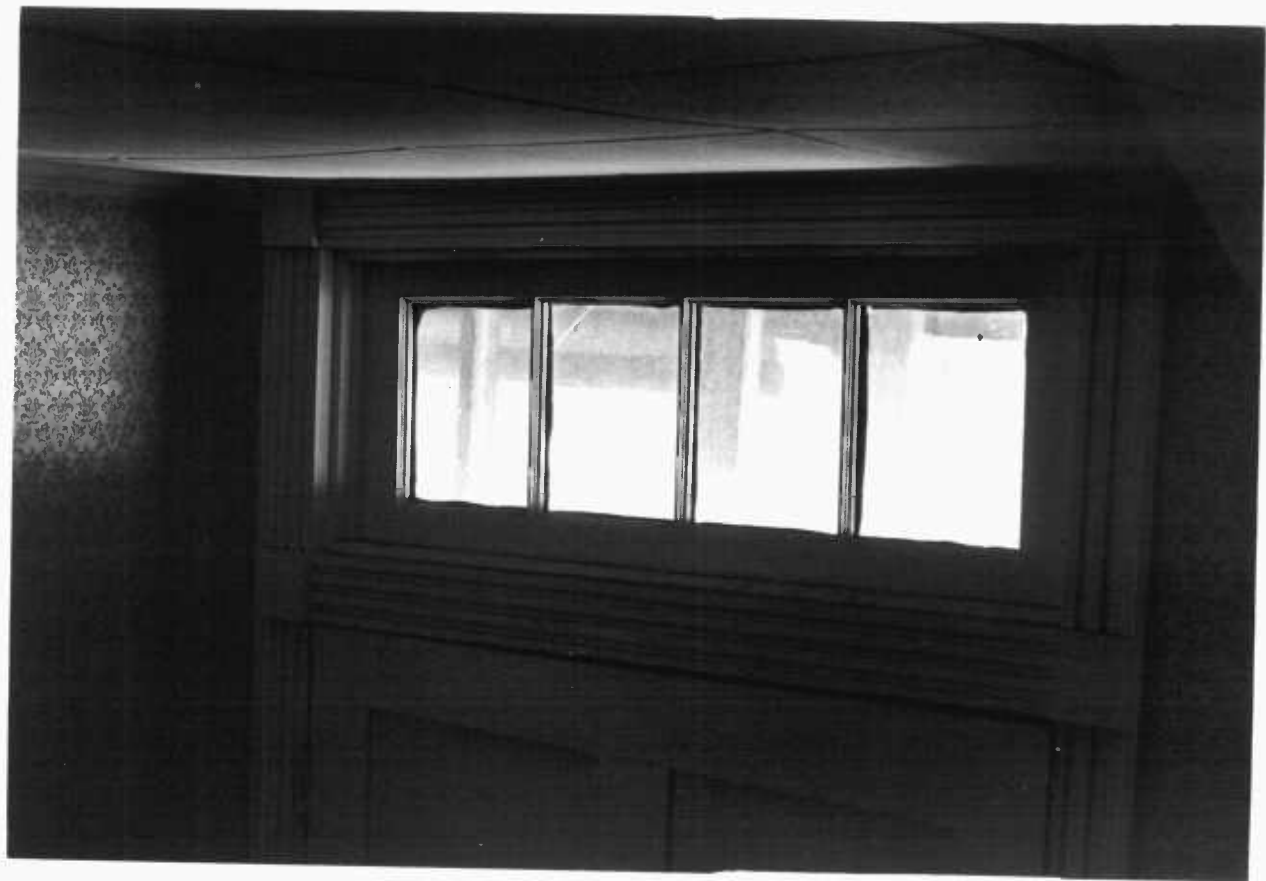
Jeptha Hayman Farm S-244
Near Kingston, Somerset County
Front Door Transom
10/84, Paul Touart, Photographer
Neg/Md. Historical Trust

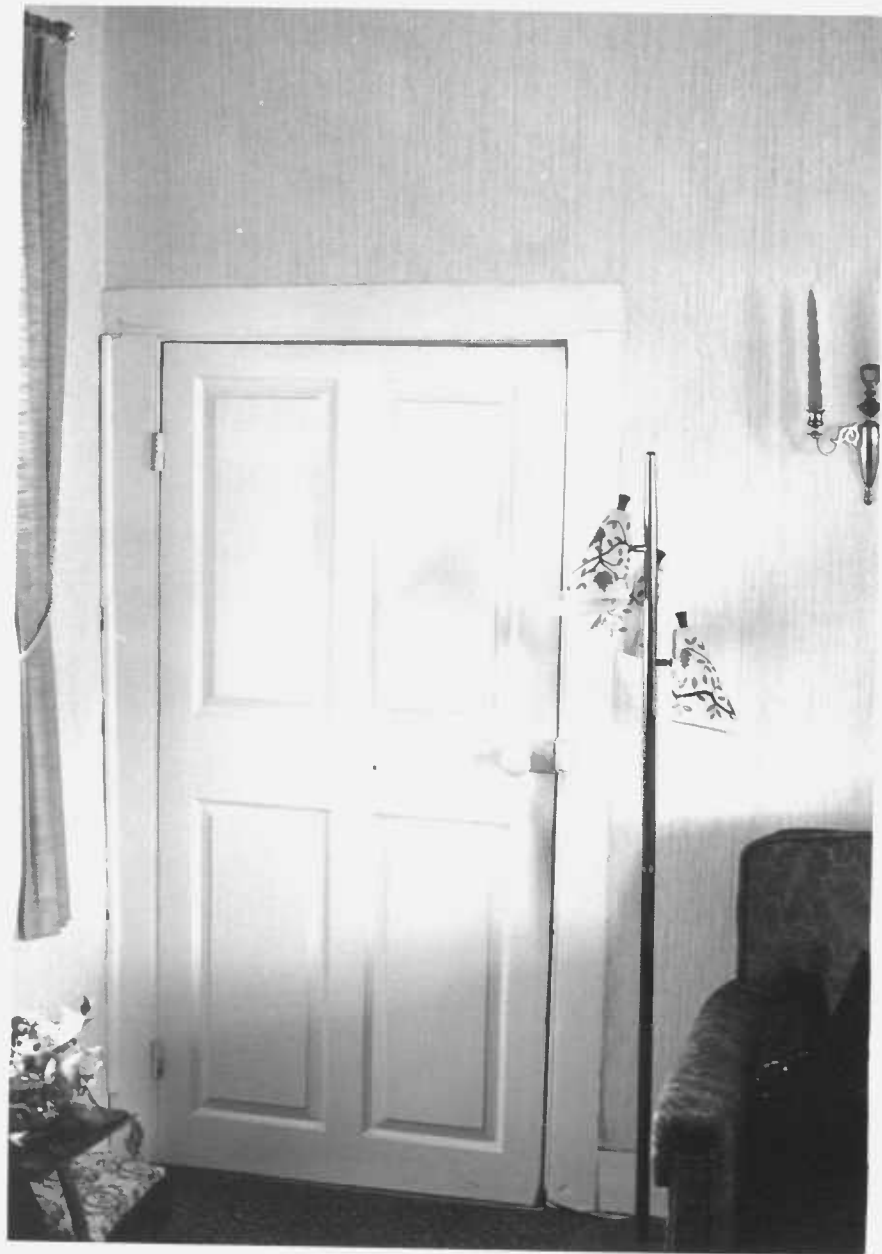
Jeptha Hayman Farm S-244
Near Kingston, Somerset County
Stair Closet-Reused Door
10/84, Paul Touart, Photographer
Neg/Md. Historical Trust

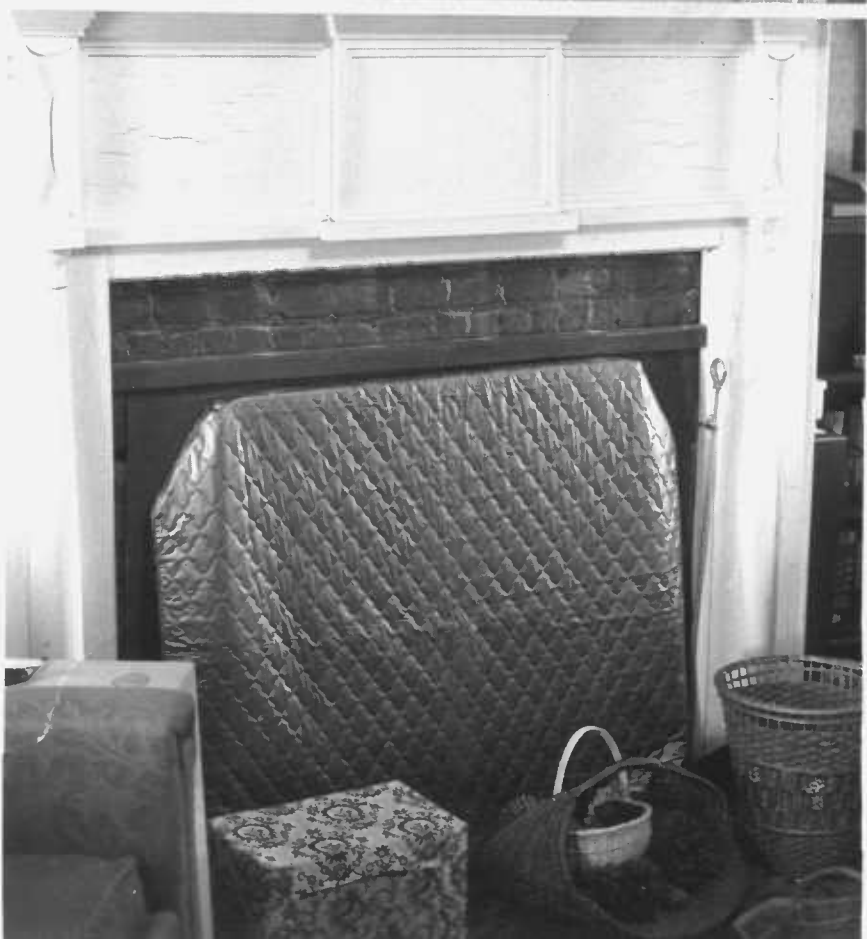
Jeptha Hayman Farm

Parlor Mantel

The Jeptha Hayman farmhouse is a significant two-story center hall farmhouse built in two principal stages and finished inside with Federal ^{and some} Greek Revival woodwork. The side hall/parlor south end of the frame house was built in 1836 (datebrick), while the north dining room was attached around 1860. The center stair survives with a square newel post, a molded cap, and a decorated stringer. A flat six-panel door opens into the south parlor which is fitted with a Greek Revival style mantel. Engaged columns flank the firebox and support a three-part paneled frieze.

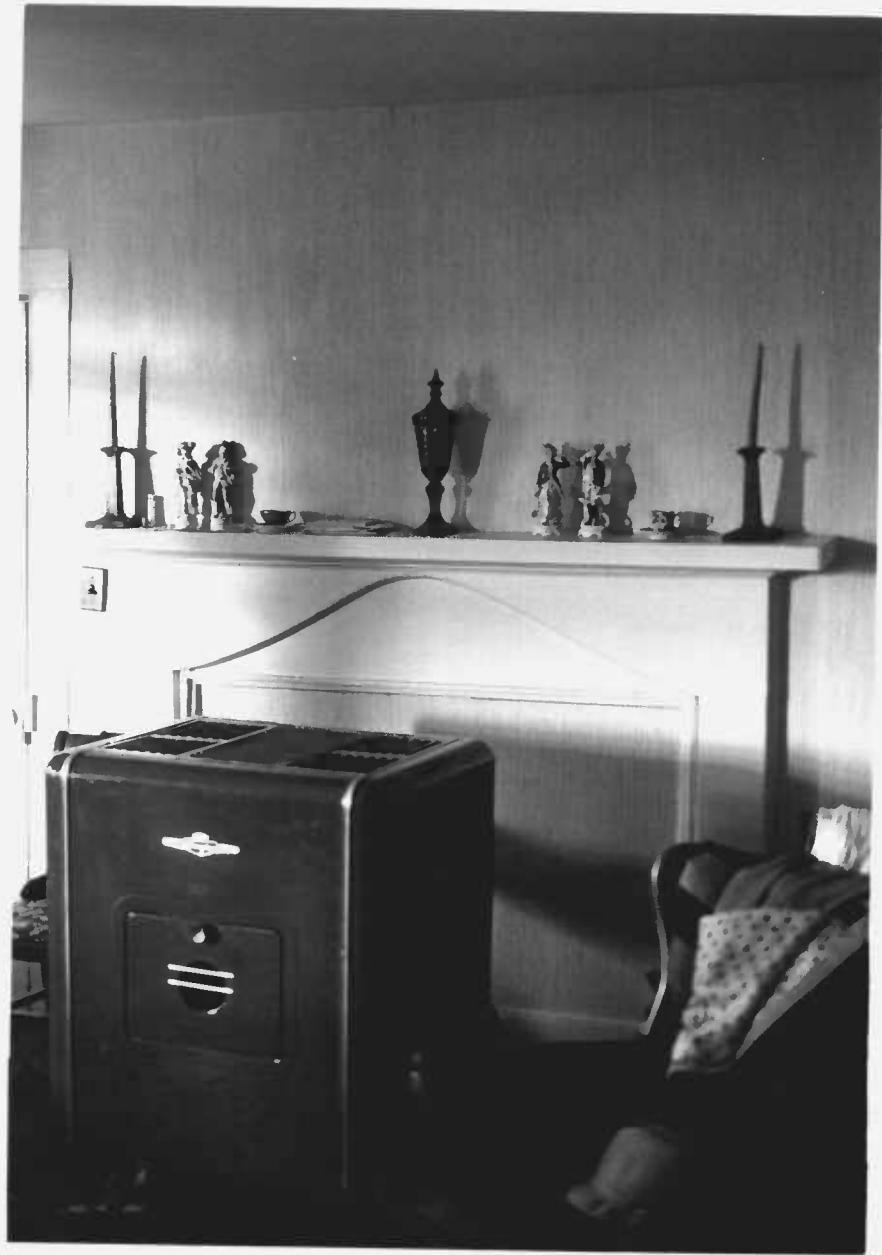
Jeptha Hayman Farm S-244
Near Kingston, Somerset County
Mantel in dining room
10/84, Photographer, Paul Touart
Neg./MD. Historical Trust

The room north of the hall, used as a dining room, is entered through a four-panel door which is not framed by a fluted surround. The mantel in the dining room is a plain mid nineteenth century form consisting of plain pilasters, a curving frieze panel, and a thick shelf. This room is not fitted with chair rail. A reused raised four-panel door is fixed in the southeast corner of the room and opens into the back end of the hall under the stair.

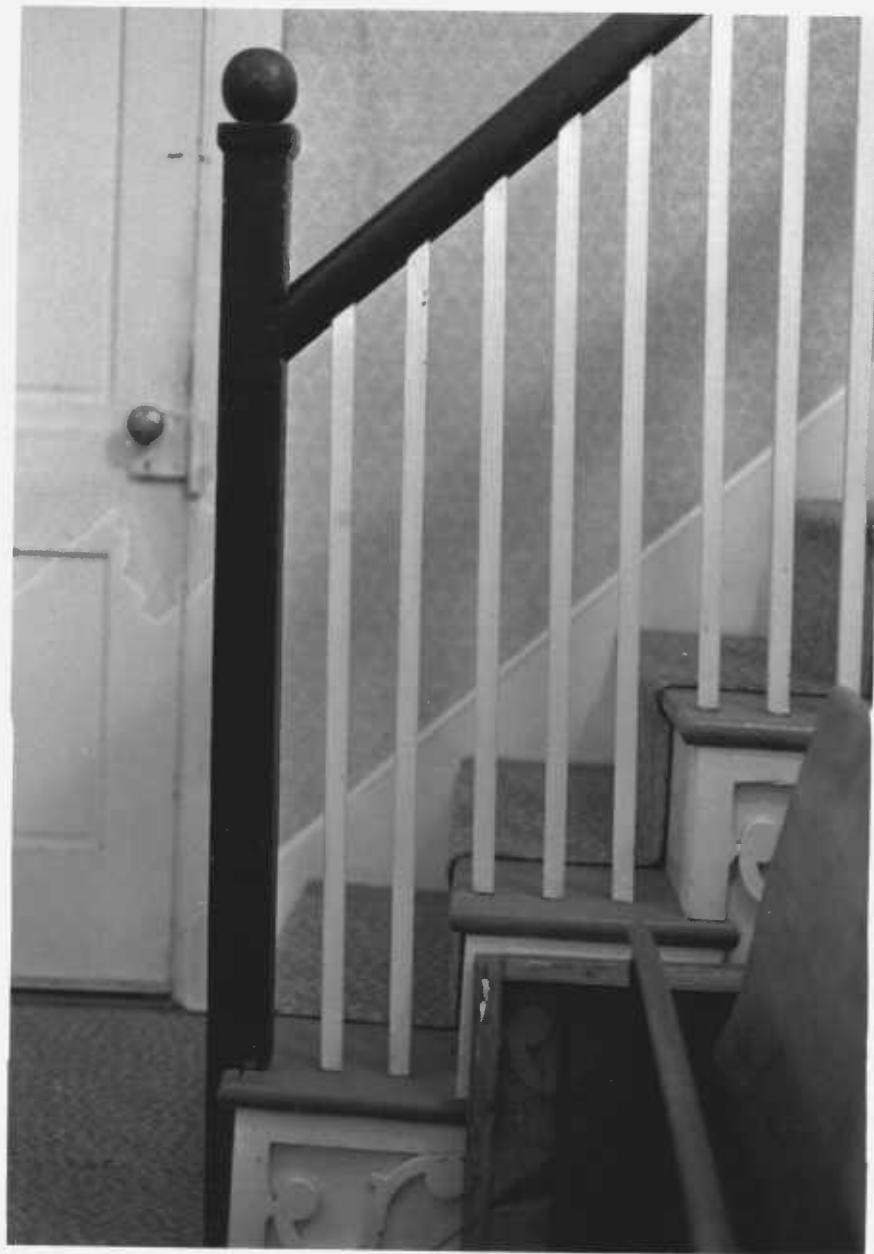
Jeptha Hayman Farm

Stair

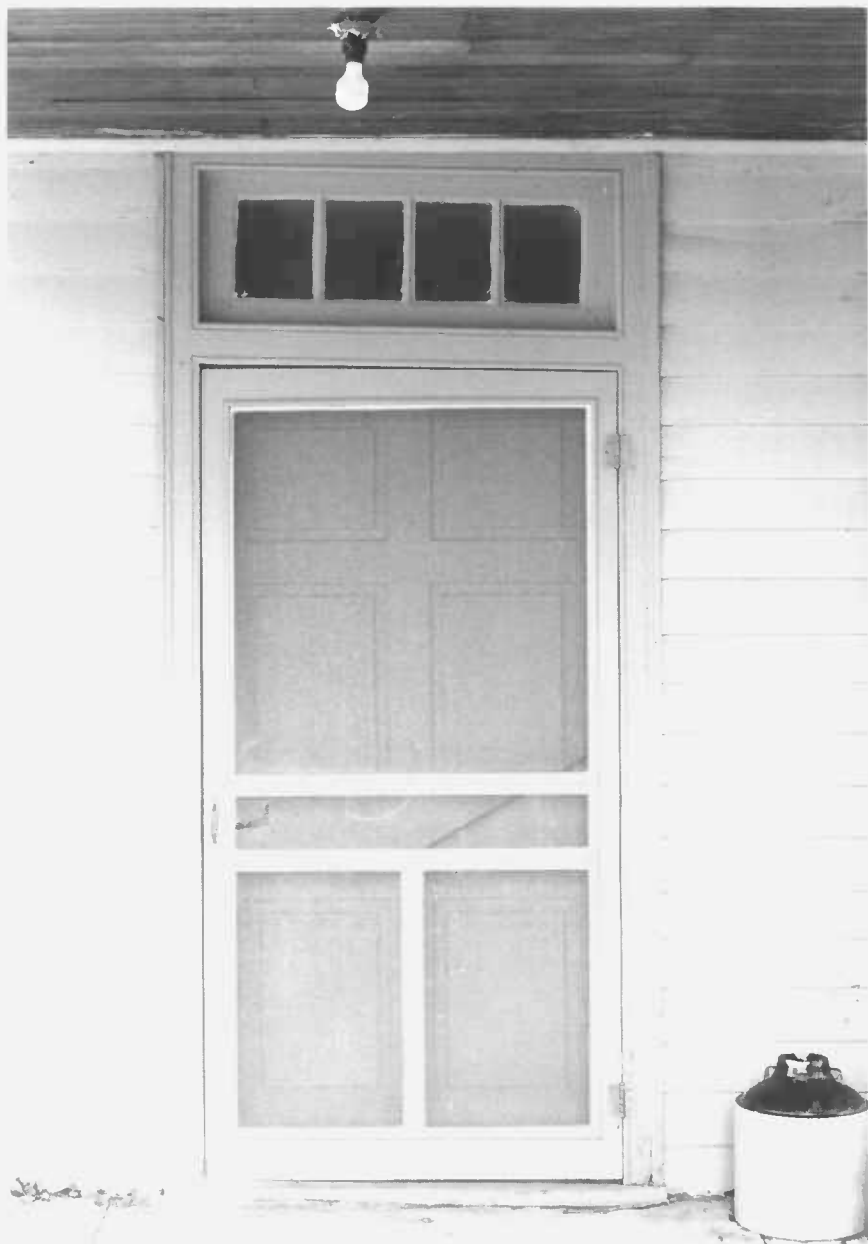
Jeptha Hayman Farm S-244
Near Kingston, Somerset County
Front Door-West Elevation
10/84, Paul Touart, Photographer
Neg/Md. Historical Trust
